Macquarie Harbour Waste Capture System (WCS)

MONTHLY PROGRESS REPORT

Report number: 4

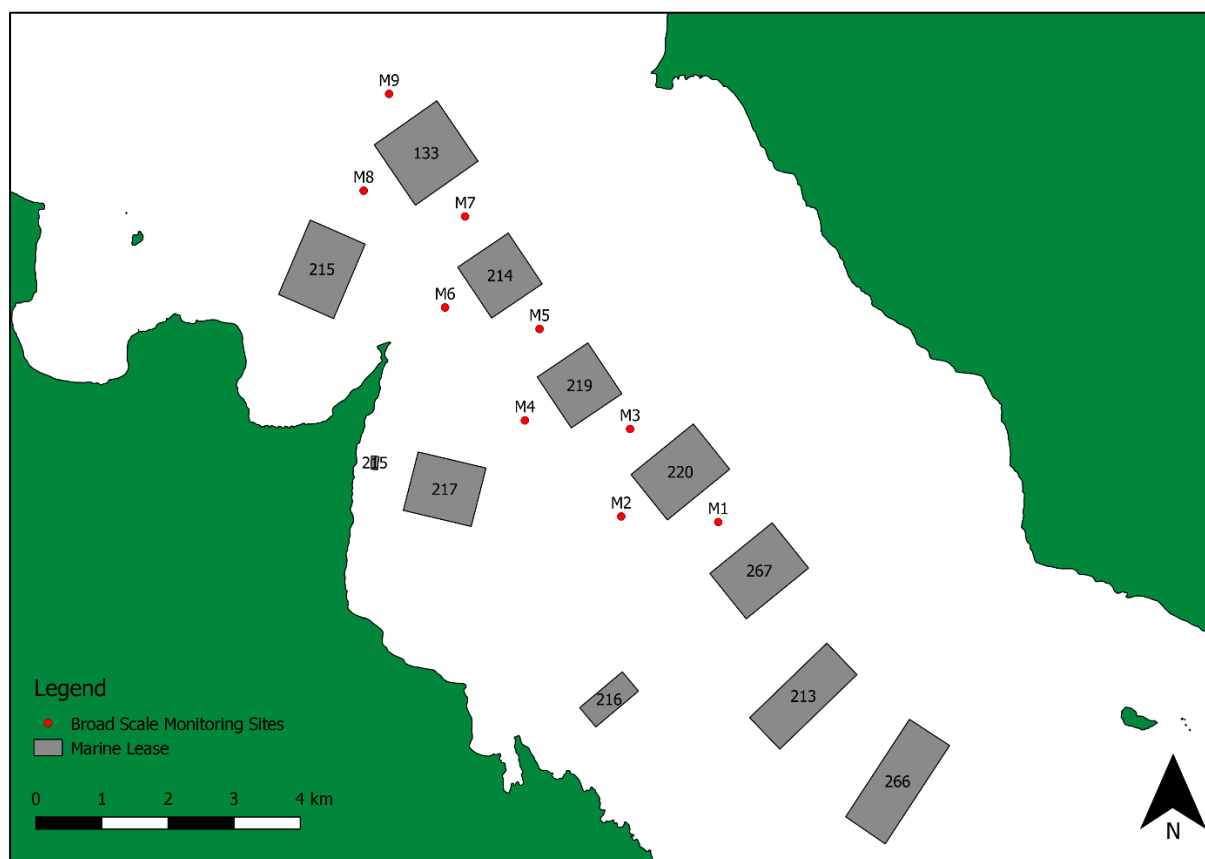
Figure 3 – Broad scale water quality monitoring sites.

Broad scale water quality monitoring was undertaken at 9 sites on 4th October 2017 (Figure 3). The sampling sequence was M1, M2, M3, M4, M5, M6, M7, M8, M9. For broad scale sites “middle” was sampled at 15 m, except M6 where “middle” was sampled at 10 m as this site is only 17 m deep. Dissolved oxygen profiles taken every meter during the October 2017 survey are depicted in Figure 4, while Table 8 shows a tabulated summary every 5 m through the water column. Dissolved oxygen concentrations at 20 m in the broad scale sites (1.16 mg/L average across 7 sites at 20 m) were generally comparable to those observed at fine scale sites at 20 m depth (0.94 mg/L average across 4 cage edge sites). Similar to the fine scale sites, dissolved oxygen concentrations in bottom waters were much lower in October (bottom water average 0.92 mg/L) at all sampling sites compared to previous surveys (e.g. September 2017; bottom water average 1.66 mg/L; September 2017). Consistent with previous sampling events, results for other analytes at broad scale sites were comparable to fine scale sites.

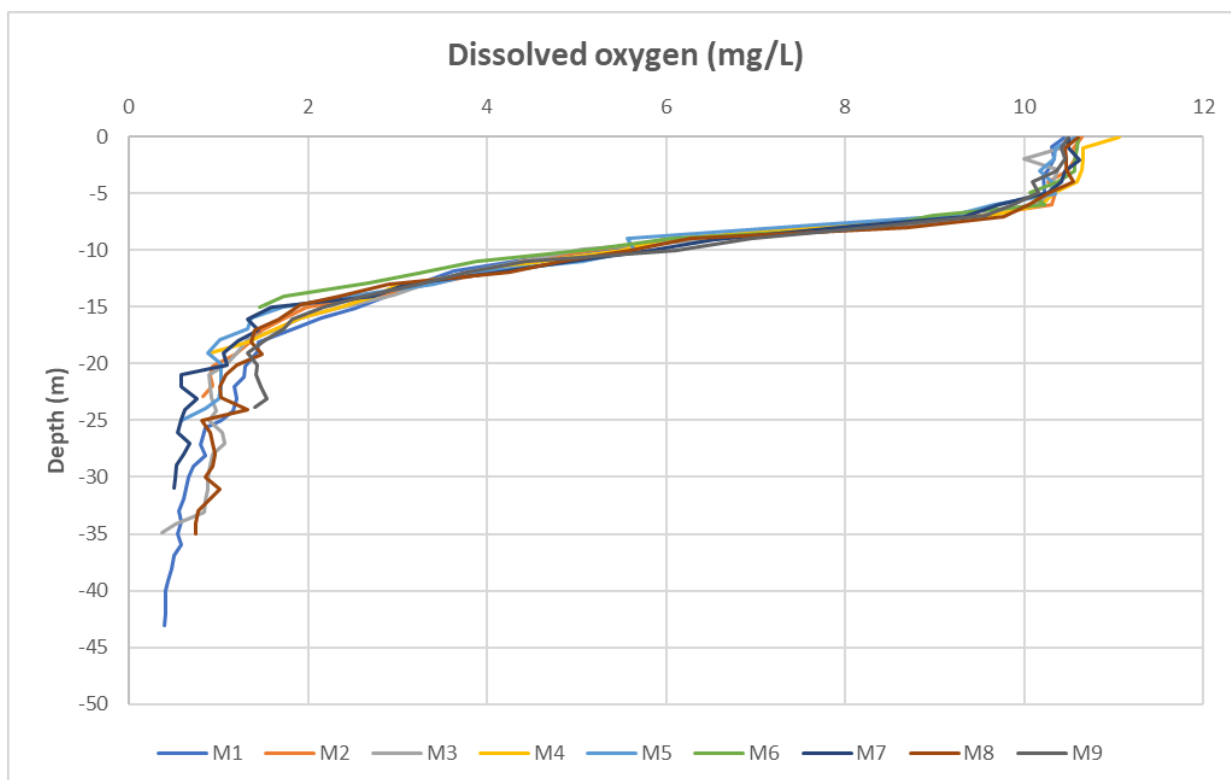
Figure 4 - Dissolved oxygen profiles for broad scale monitoring sites, October 2017.
